MISCELLANEOUS PAPER HL-89-4

SCOUR PROTECTION FOR MORGANTOWN DAM MONONGAHELA RIVER, WEST VIRGINIA

Hydraulic Model Investigation

August 1989

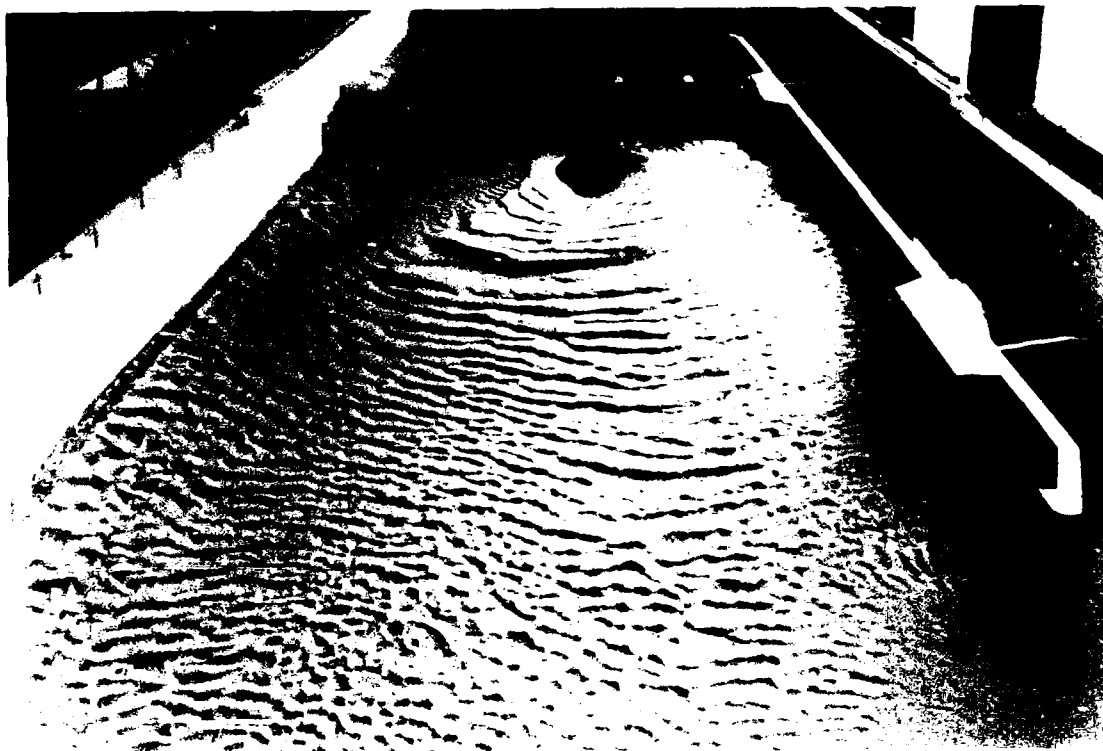
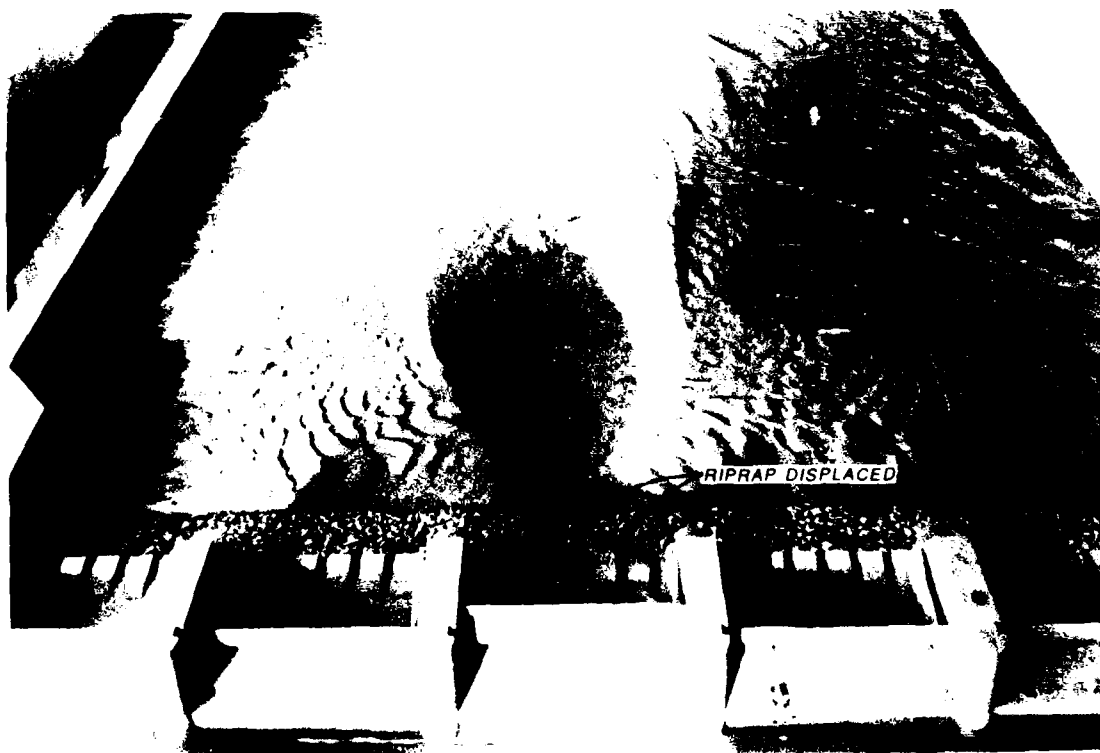
All tests were conducted using gate 3, which was one of the center-bays of the model, unless stated otherwise. After completion of the test, the model was drained slowly and results indicated that the type 1 riprap plan had failed. Another test was conducted with normal upper pool and tailwater, and a 6-ft gate opening, for a duration of 5 hr. The results shown in Photo 1 indicate riprap was displaced throughout the entire blanket and this was considered failure since displacement occurred so quickly. Flow conditions for normal operating conditions with 6- and 8-ft gate openings are shown in Photos 2 and 3, respectively. Supercritical flow exits the existing basin and plunges through the tailwater severely attacking the area below the basin and creating undesirable flow conditions for these gate settings and tailwaters.

Photo 1. Type 1 riprap protection plan, scour after 5 hr of operation:
normal pool el 814, normal tailwater el 803.6, gate opening 6 ft

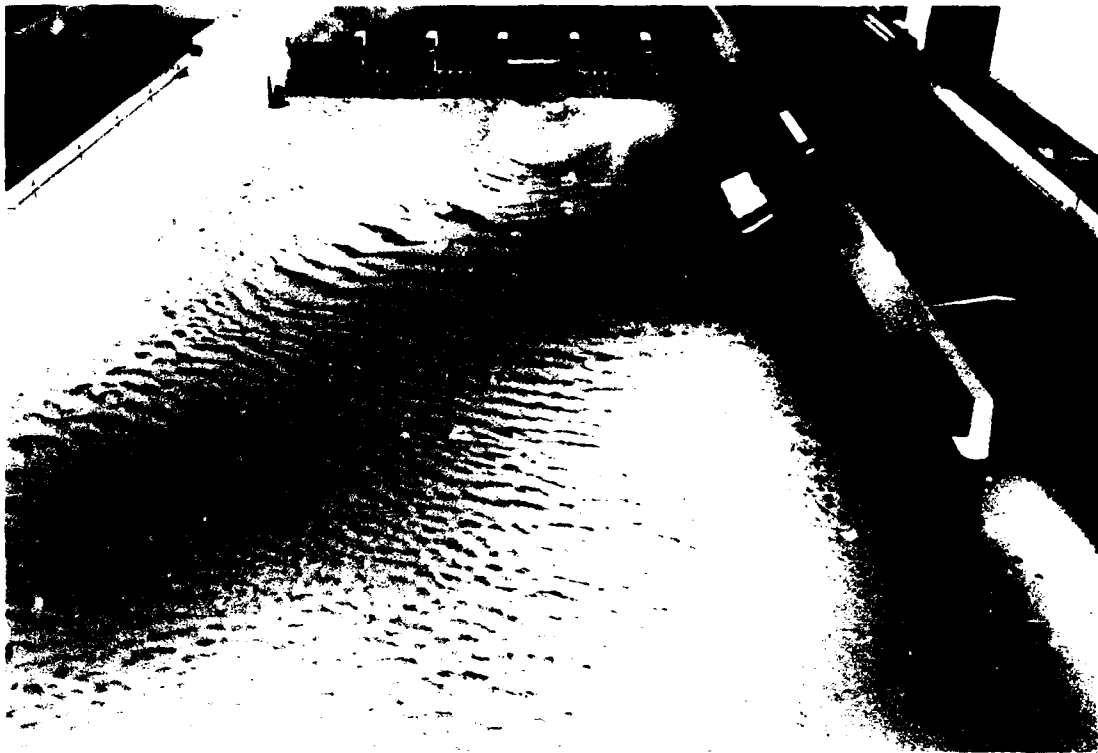
10. The type 1 riprap plan was replaced with the type 2 riprap plan shown in Plate 3. This plan consisted of 4- to 5-ft-diameter stones placed in the same manner as the type 1 riprap plan. The type 2 riprap plan was tested for 5 hr (prototype) with normal operating conditions for a 6-ft gate opening. The plan remained stable and results from this test are shown in Photo 4. The weight of the 4- to 5-ft-diameter stones was sufficient to resist displacement with this flow condition. A test was then conducted with normal upper pool, a 6-ft gate opening and gradually lowering the tailwater in an attempt to reach the minimum tailwater elevation. The type 2 riprap plan failed when the tailwater elevation reached 797.8, 0.8 ft higher than the minimum, as shown in Photo 5. This procedure was repeated for a 3-ft gate opening and the riprap again failed when the tailwater reached el 797.8. The type 2 riprap plan was then tested to determine if it would remain stable for 5 hr of operation with normal upper pool and tailwater (799.7) and a 3-ft gate opening. The riprap was unstable for these conditions and had the previous tests with 6- and 8-ft gate openings been conducted for 5 hr, failure probably would have occurred for tailwater elevations higher than 797.8.

Photo 4. Type 2 riprap protection plan, scour after 5 hr of operation;
pool el 814, tailwater el 803.6, gate opening 6 ft

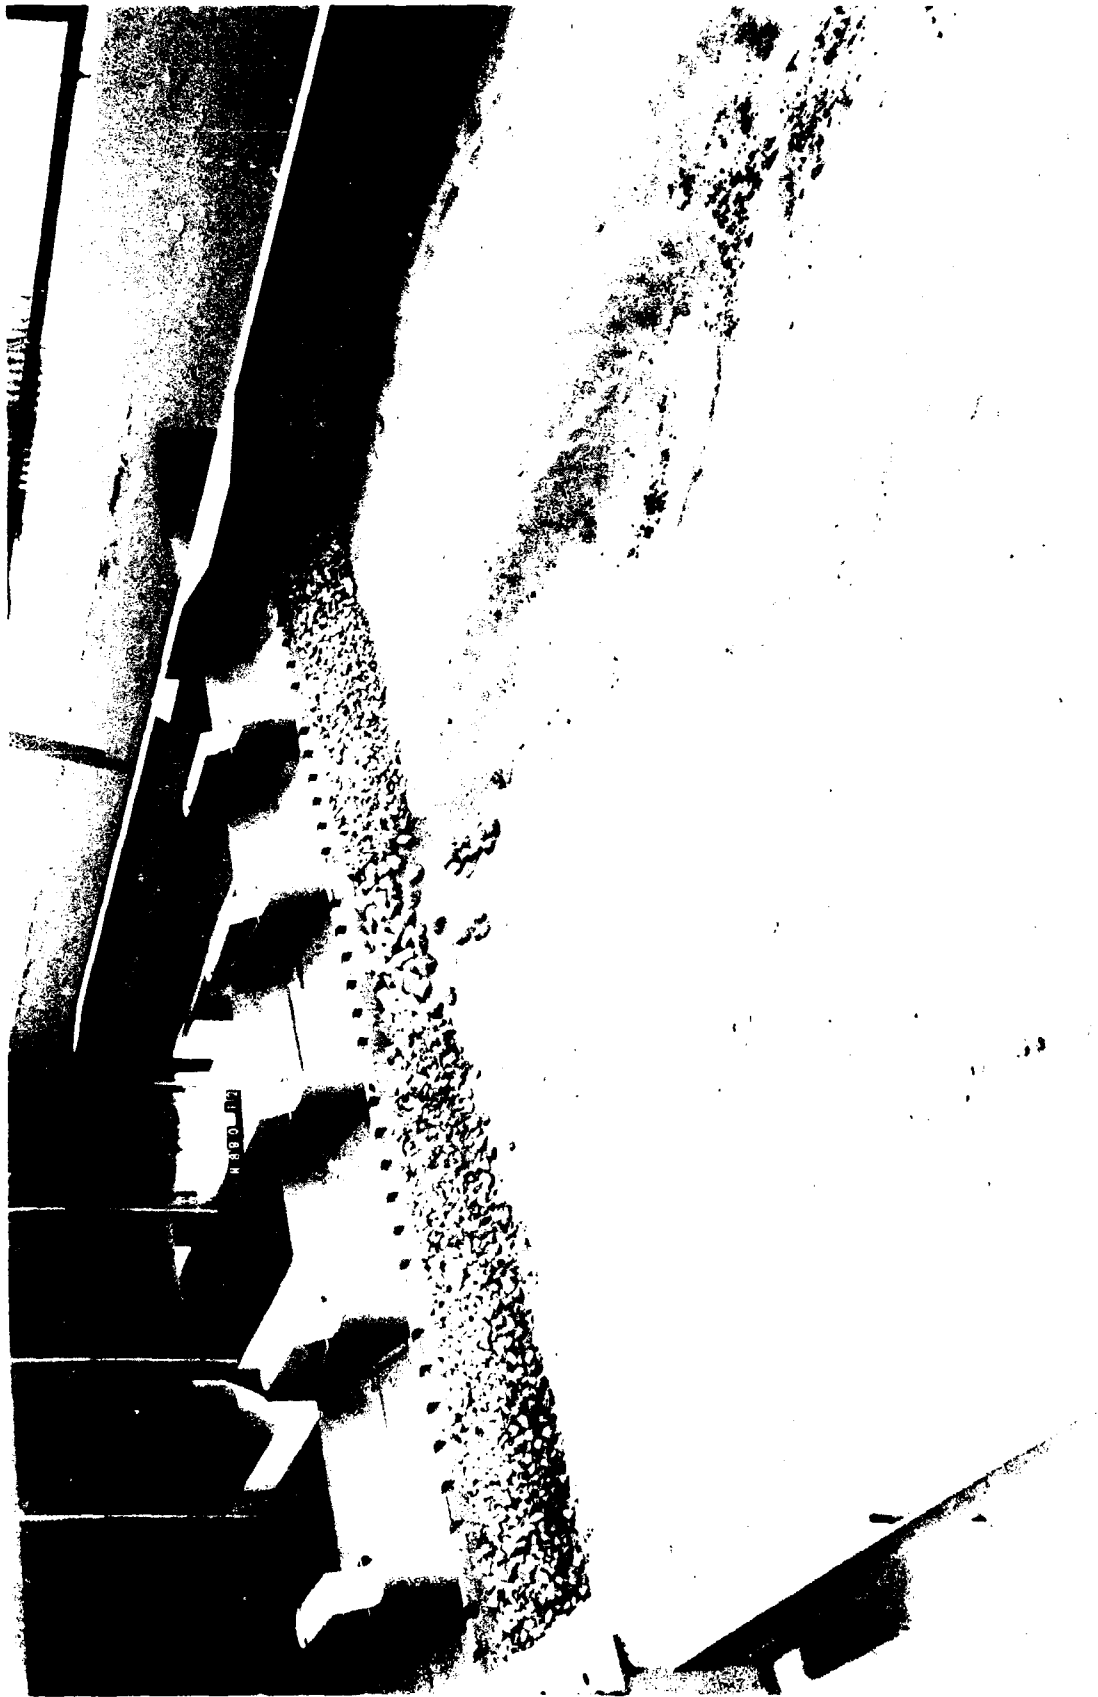
Photo 5. Failure of type 2 riprap protection plan

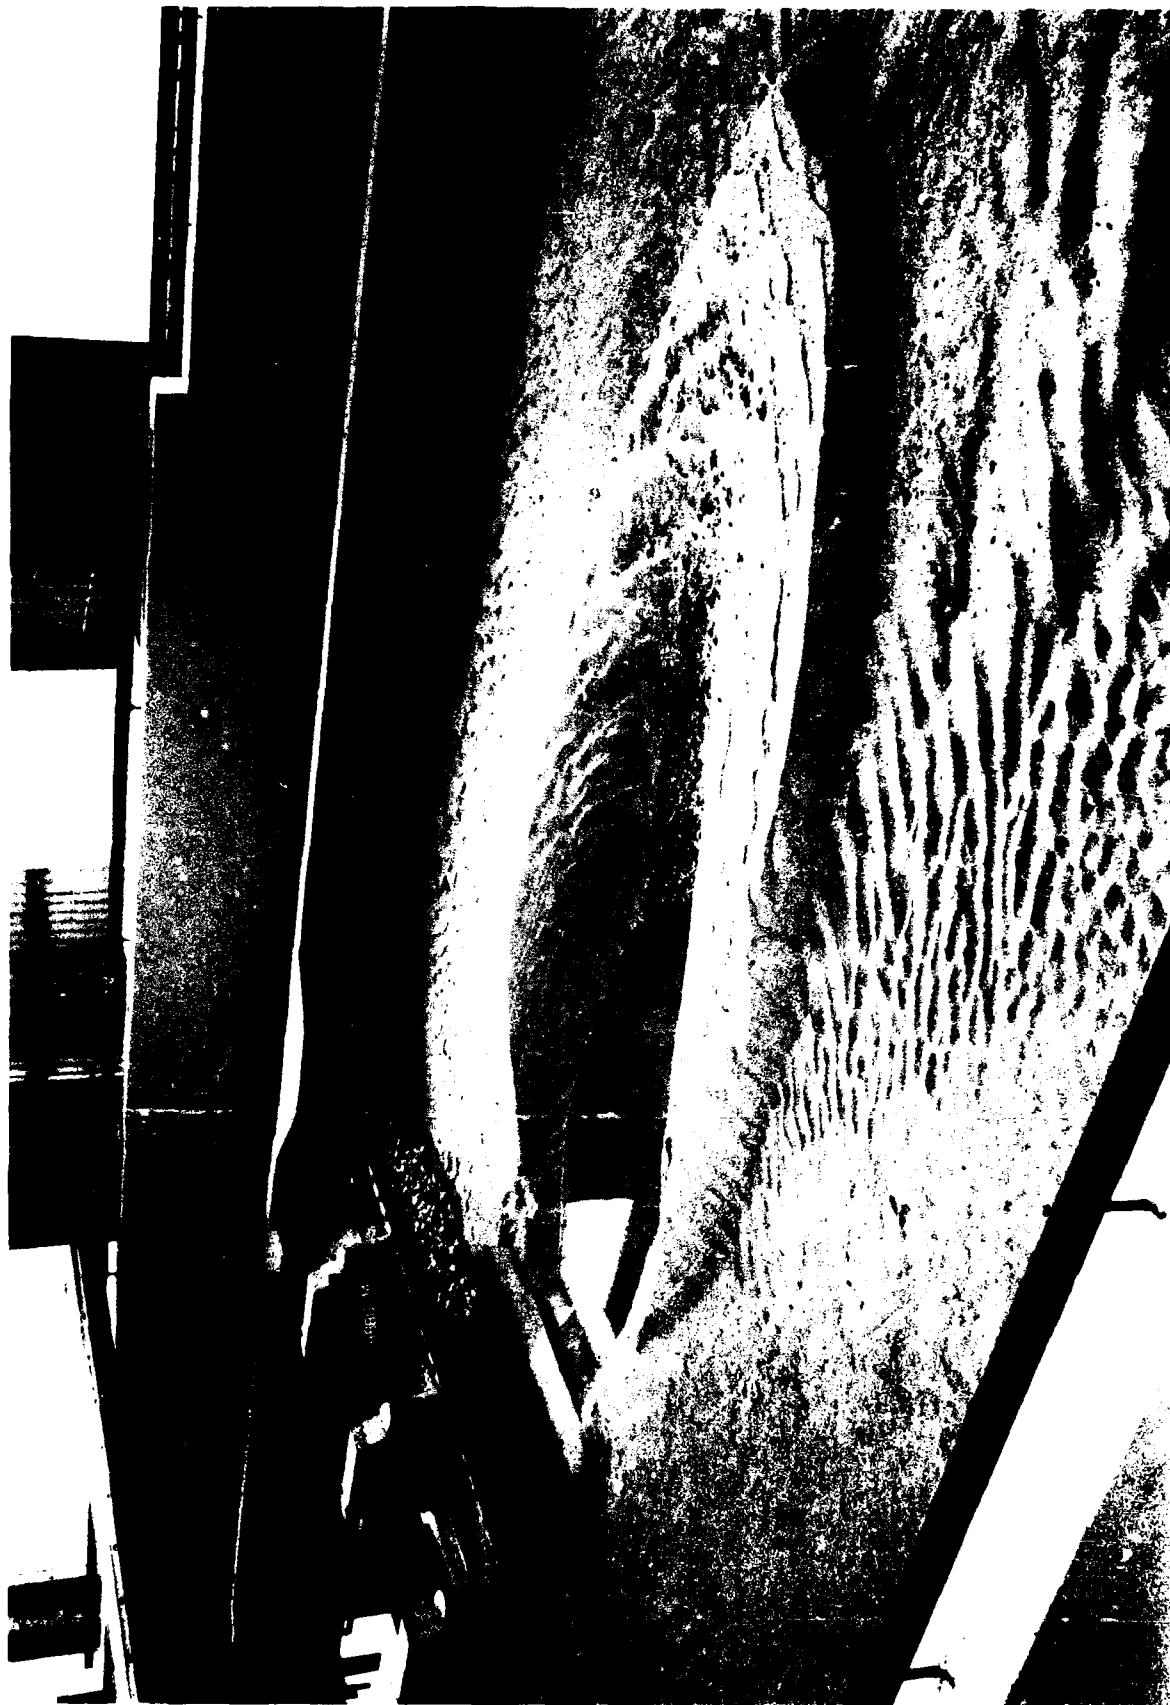
15. The type 7 scour protection plan, Plate 7, consisted of placing a 26-ft-wide barge immediately downstream from the stilling basin on a 1V on 6.5H downward slope beginning at el 793, followed by a barge placed horizontally with the top of this barge at el 789. Riprap was not placed below the barges so scouring tendencies immediately downstream from the barges could be observed. A test was conducted with normal upper pool and tailwater elevations for a 6-ft gate opening. After a 5 hr (prototype) test, scour downstream was excessive and the void under the barge, Photo 7, indicated the necessity for protection placed downstream from the barges.

Photo 7. Scour below type 7 scour protection plan

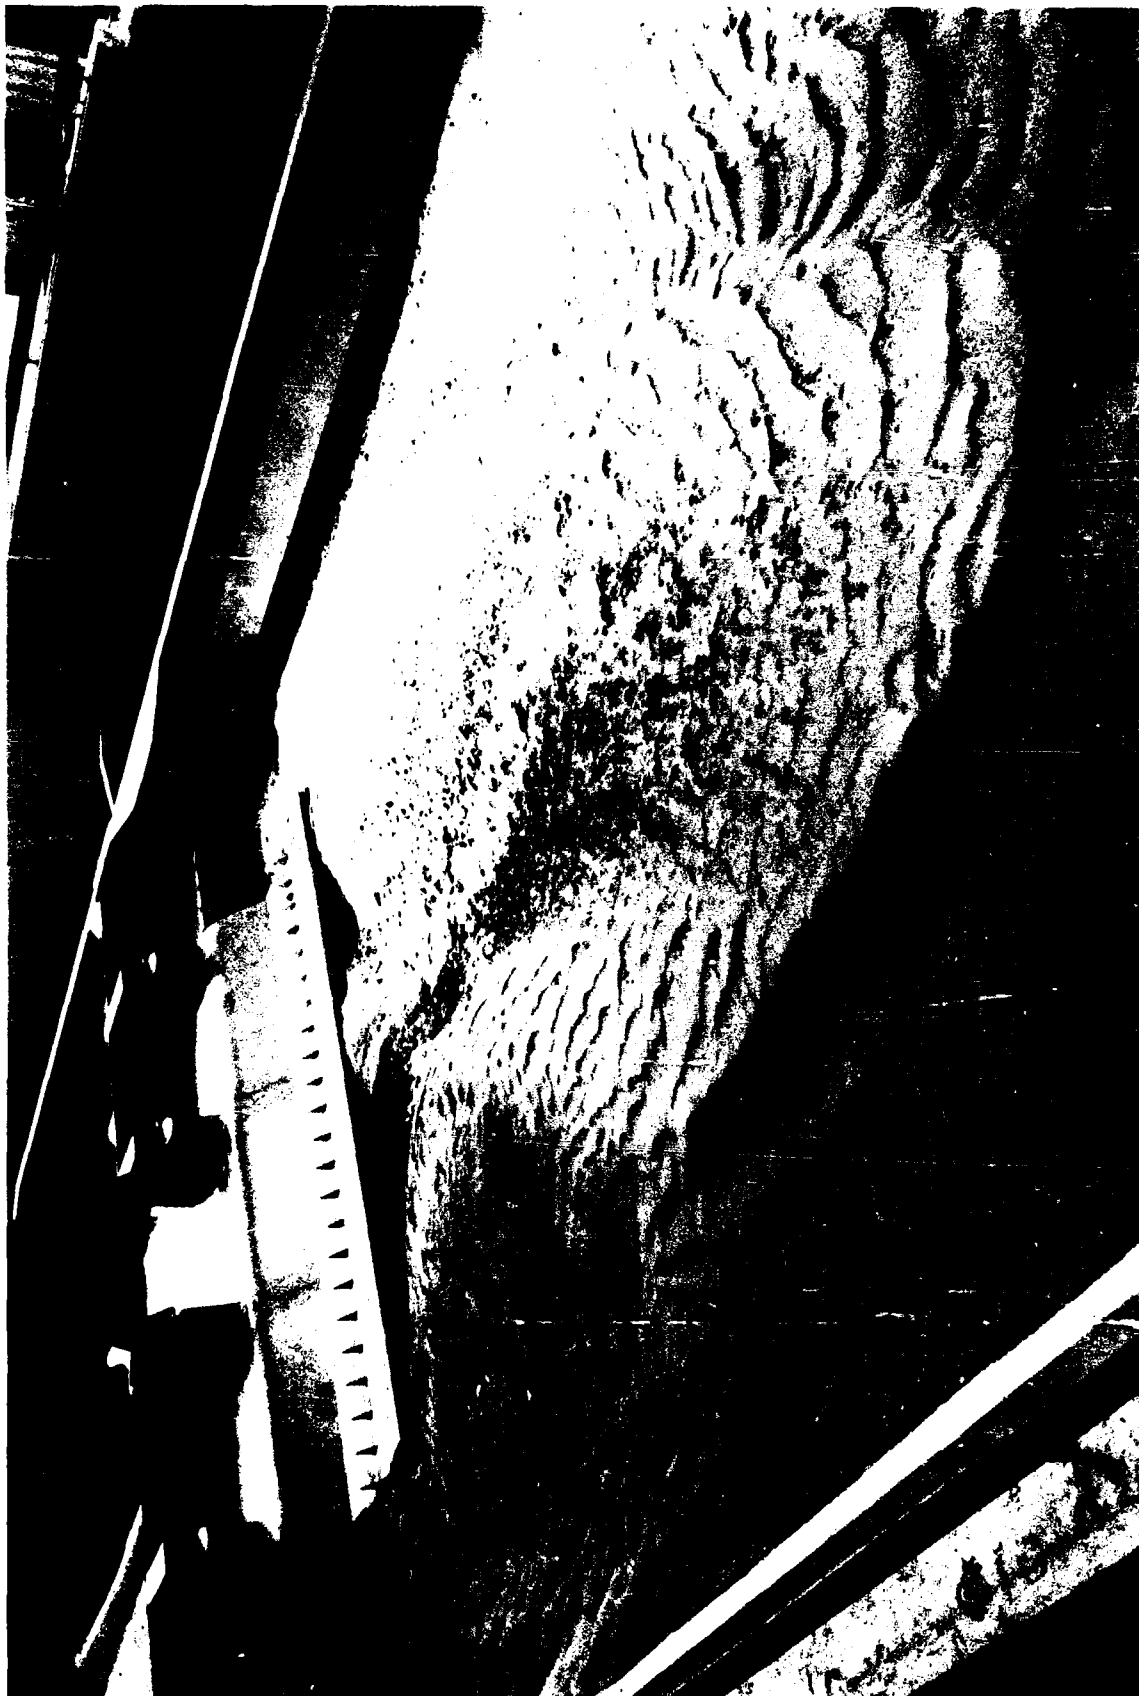
17. Preceding tests revealed the magnitude of supercritical flow exiting the existing structure could only be effectively tempered by installing a secondary stilling basin below the structure. The type 8 scour protection plan was designed with a secondary stilling basin and with the existing stilling basin filled in to improve entrance conditions into the secondary stilling basin, as shown in Plate 8. Initially, no protection was placed below the basin so the scour in the exit channel could be observed. Scour in the exit channel after 5 hr of operation with normal upper pool, gate 3 open full, and minimum tailwater is shown in Photo 10. Energy dissipation in the stilling basin was considered marginal and significant scour occurred in the exit channel.

Photo 10. Scour downstream of type 8 scour protection plan after 5 hr of operation with normal upper pool, gate 3 open full and minimum tailwater

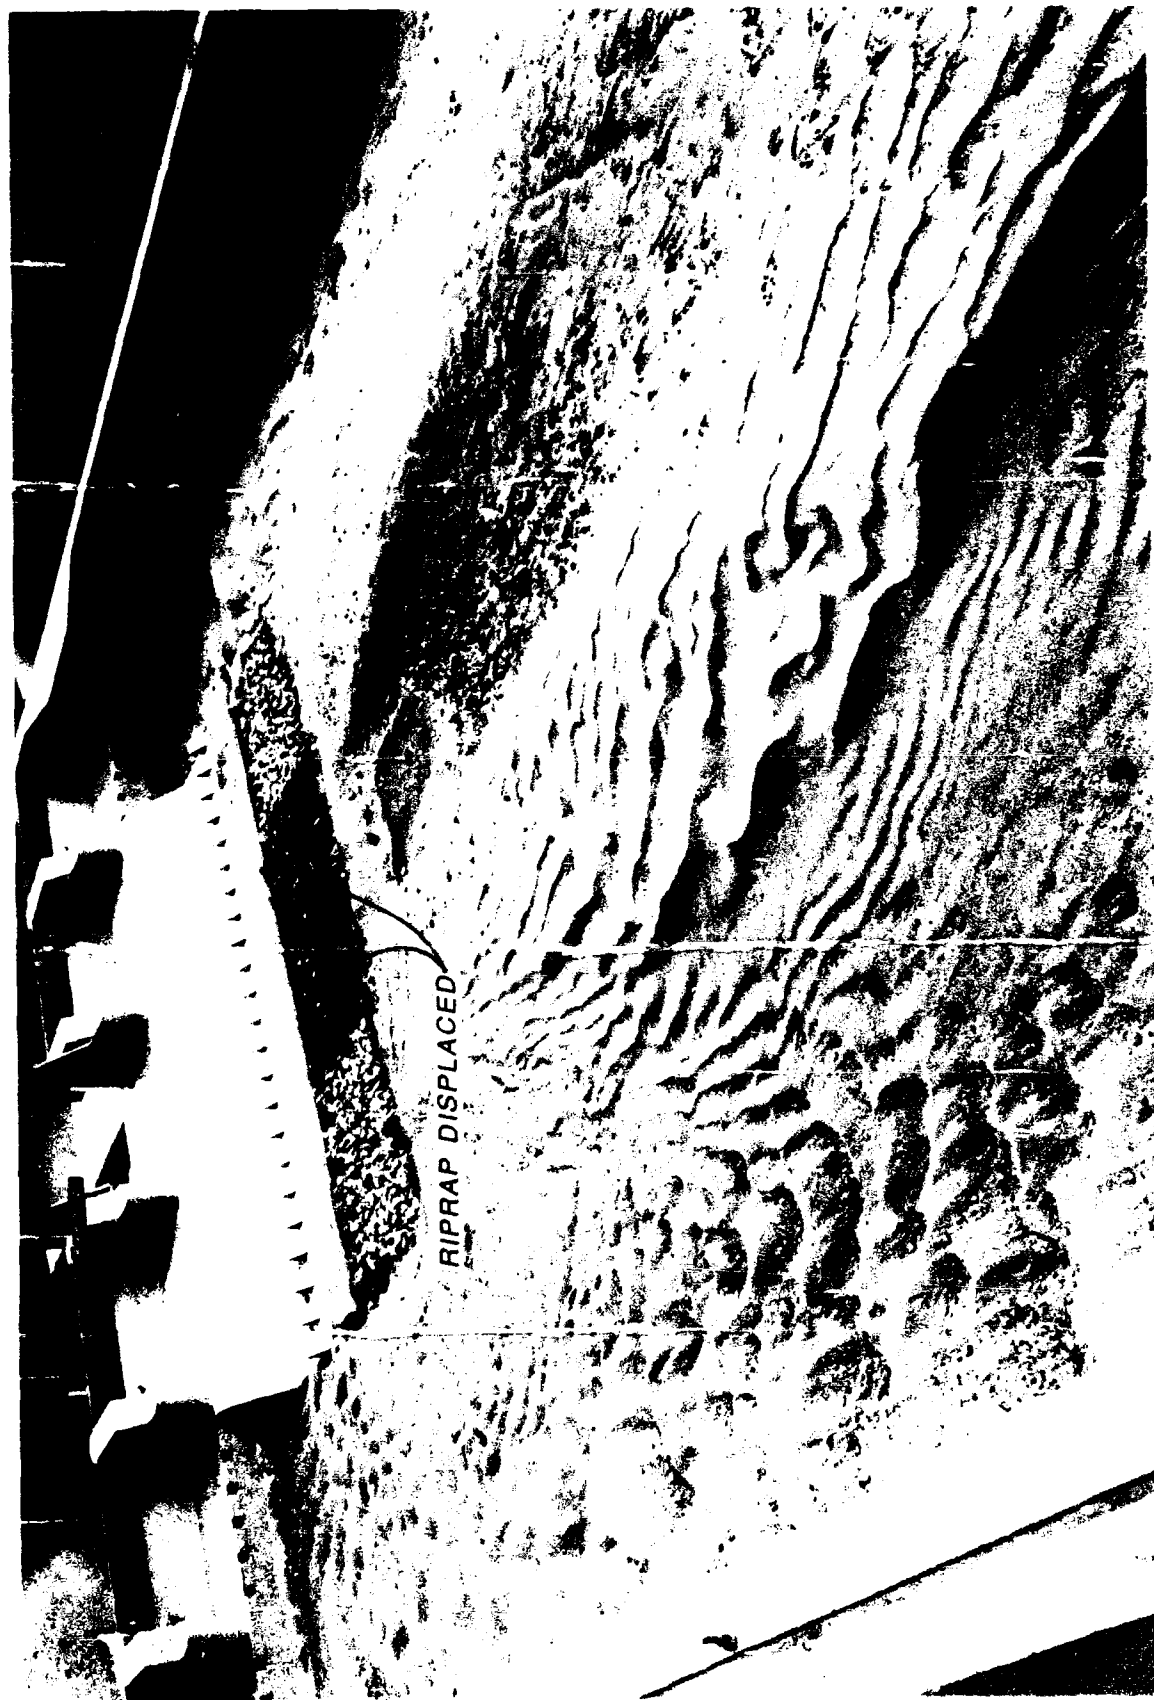
Photo 11. Riprap failure downstream of type 9 scour protection plan after 5 hr of operation with normal upper pool, gate 3 open full and minimum tailwater

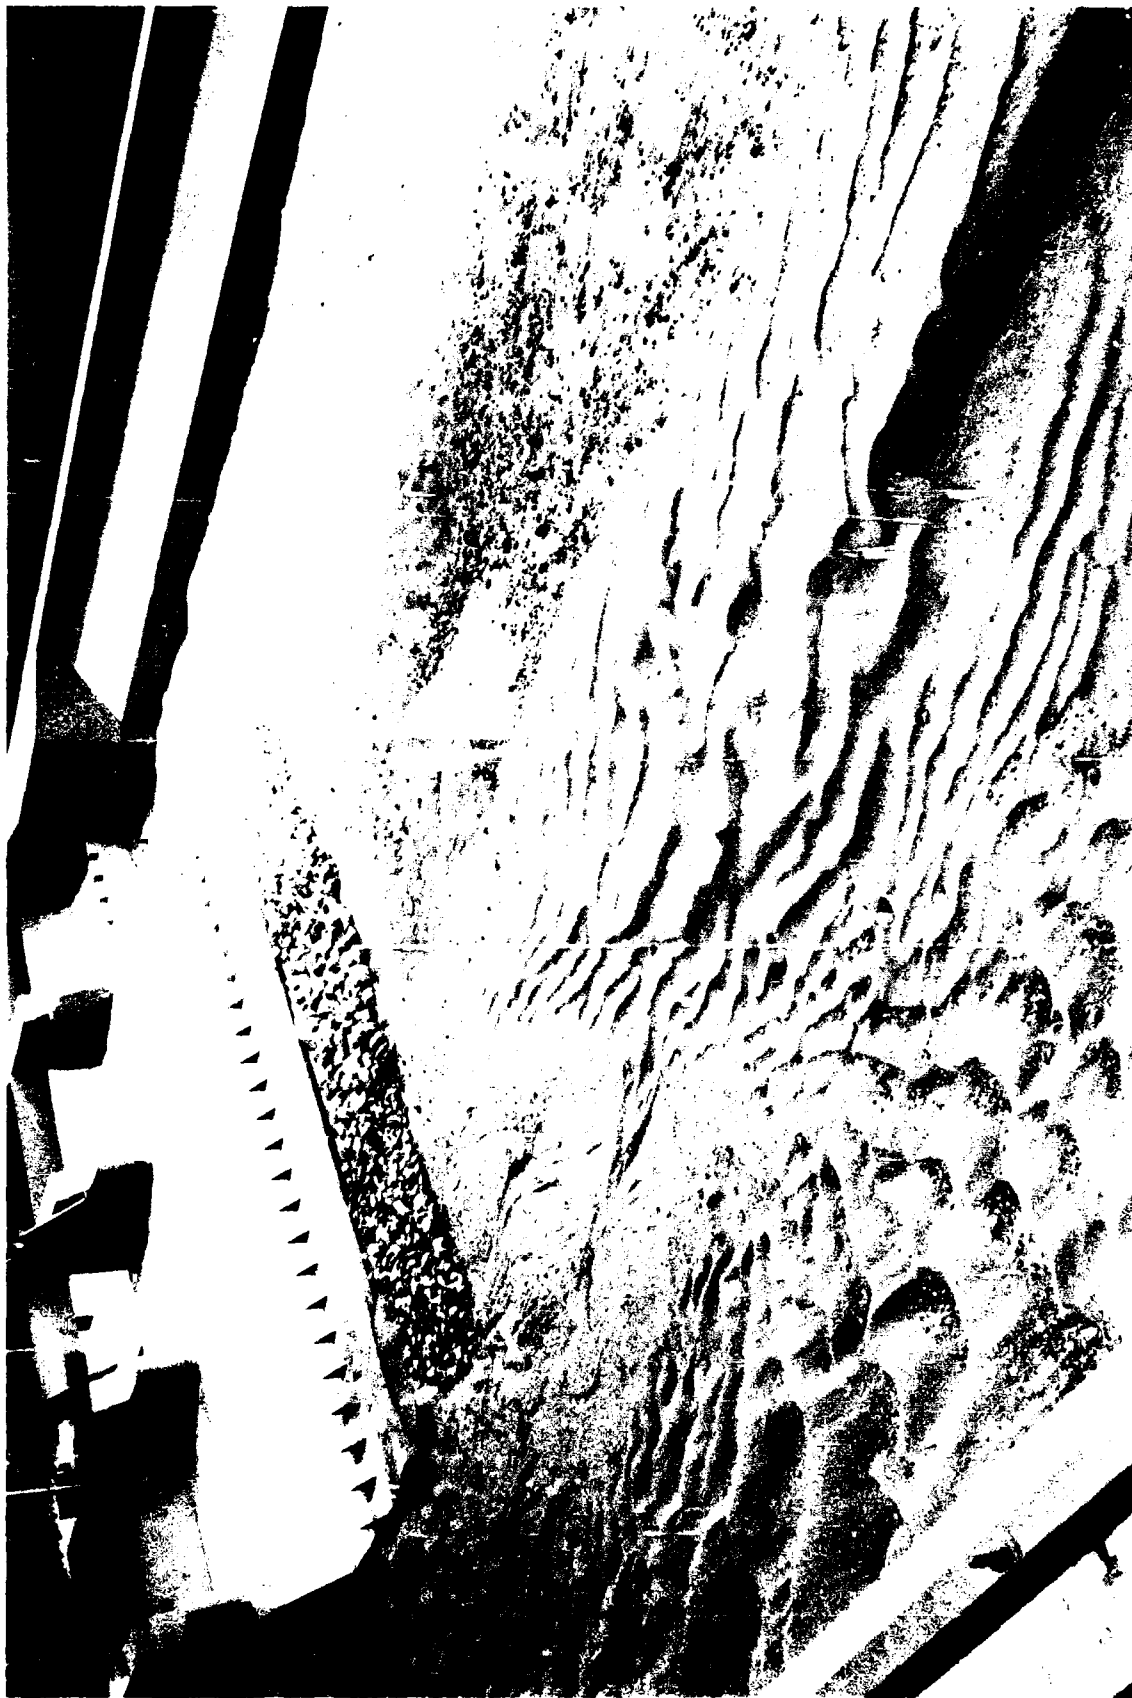
19. The 54-in.-thick blanket of graded riprap was replaced with 4- to 5-ft-diameter stones to form the type 10 scour protection plan shown in Plate 10. The stones in this plan remained stable during 5 hr of operation with gate 3 open full and minimum tailwater. Results from this test are shown in Photo 12.

Photo 12. Type 10 scour protection plan after 5 hr of operation with normal upper pool, gate 3 open full and minimum tailwater

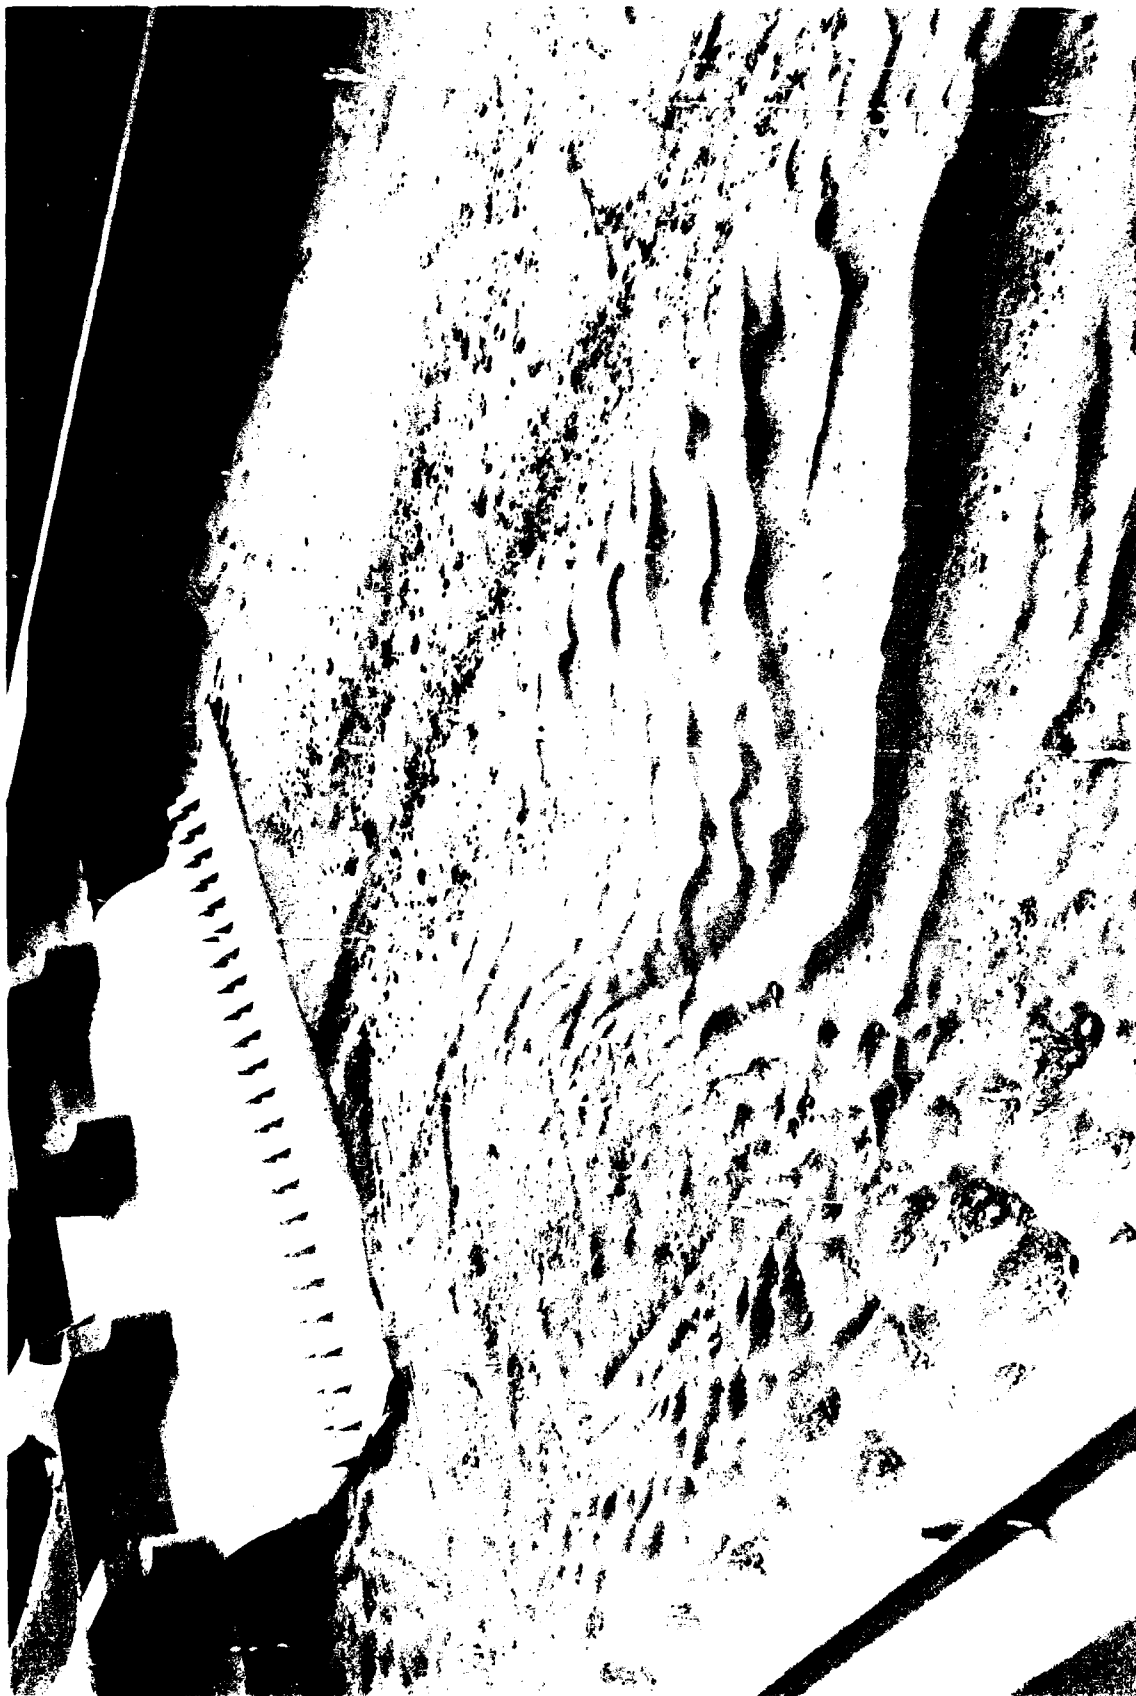
Photo 13. Scour downstream of type 11 scour protection plan after 5 hr of operation with normal upper pool, gate 3 open full and minimum tailwater

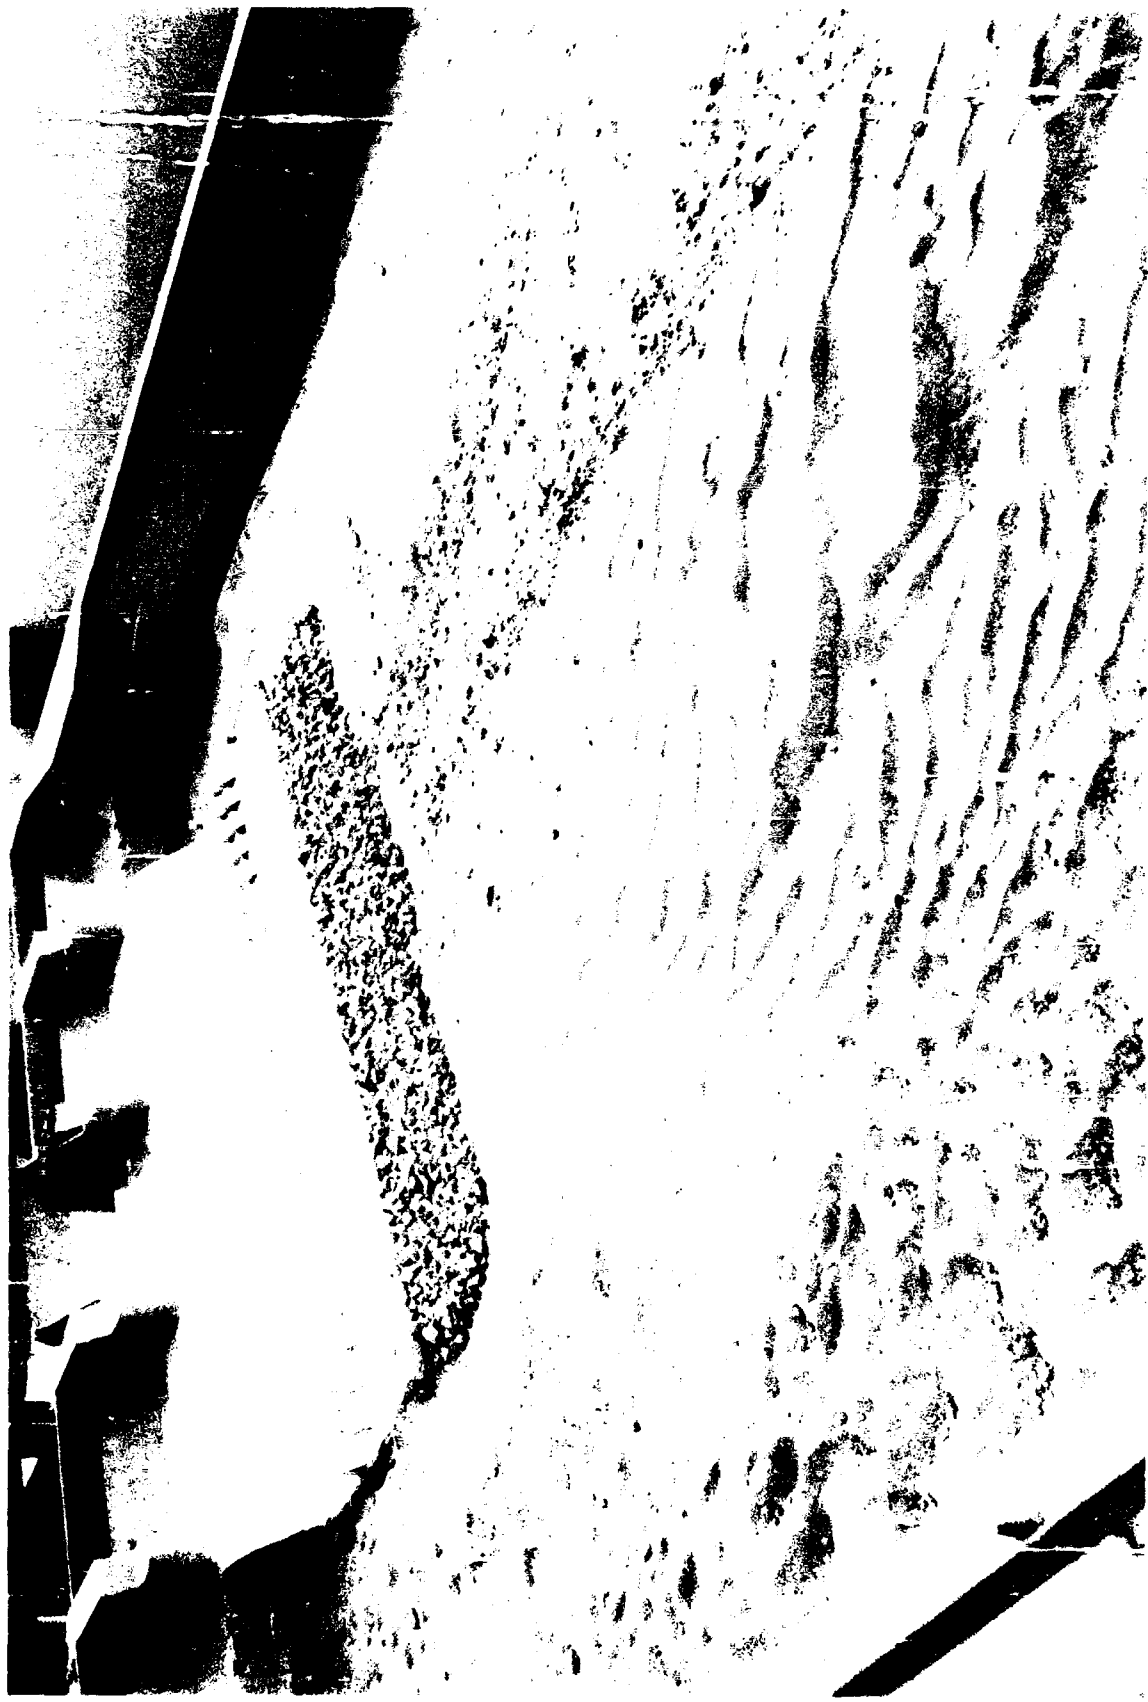
21. A 54-in.-thick blanket of riprap with an average D_{50} size stone of 27 in. was placed below the secondary stilling basin, the type 12 scour protection plan shown in Plate 12. This design was tested and remained stable after 5 hr of operation with normal upper pool, gate 3 open full, and minimum tailwater. Results from this test are shown in Photo 14, and flow conditions with this operation are shown in Photo 15. An additional test was conducted with the upper pool raised 9.6 ft higher than normal, gate 3 open full, and minimum tailwater. This is the maximum pool elevation before flow over the lock wall occurs. The type 12 scour protection plan remained stable during 5 hr of operation with these conditions and results from this test are shown

Photo 14. Type 12 scour protection plan after 5 hr of operation with normal upper pool, gate 3 open full and minimum tailwater

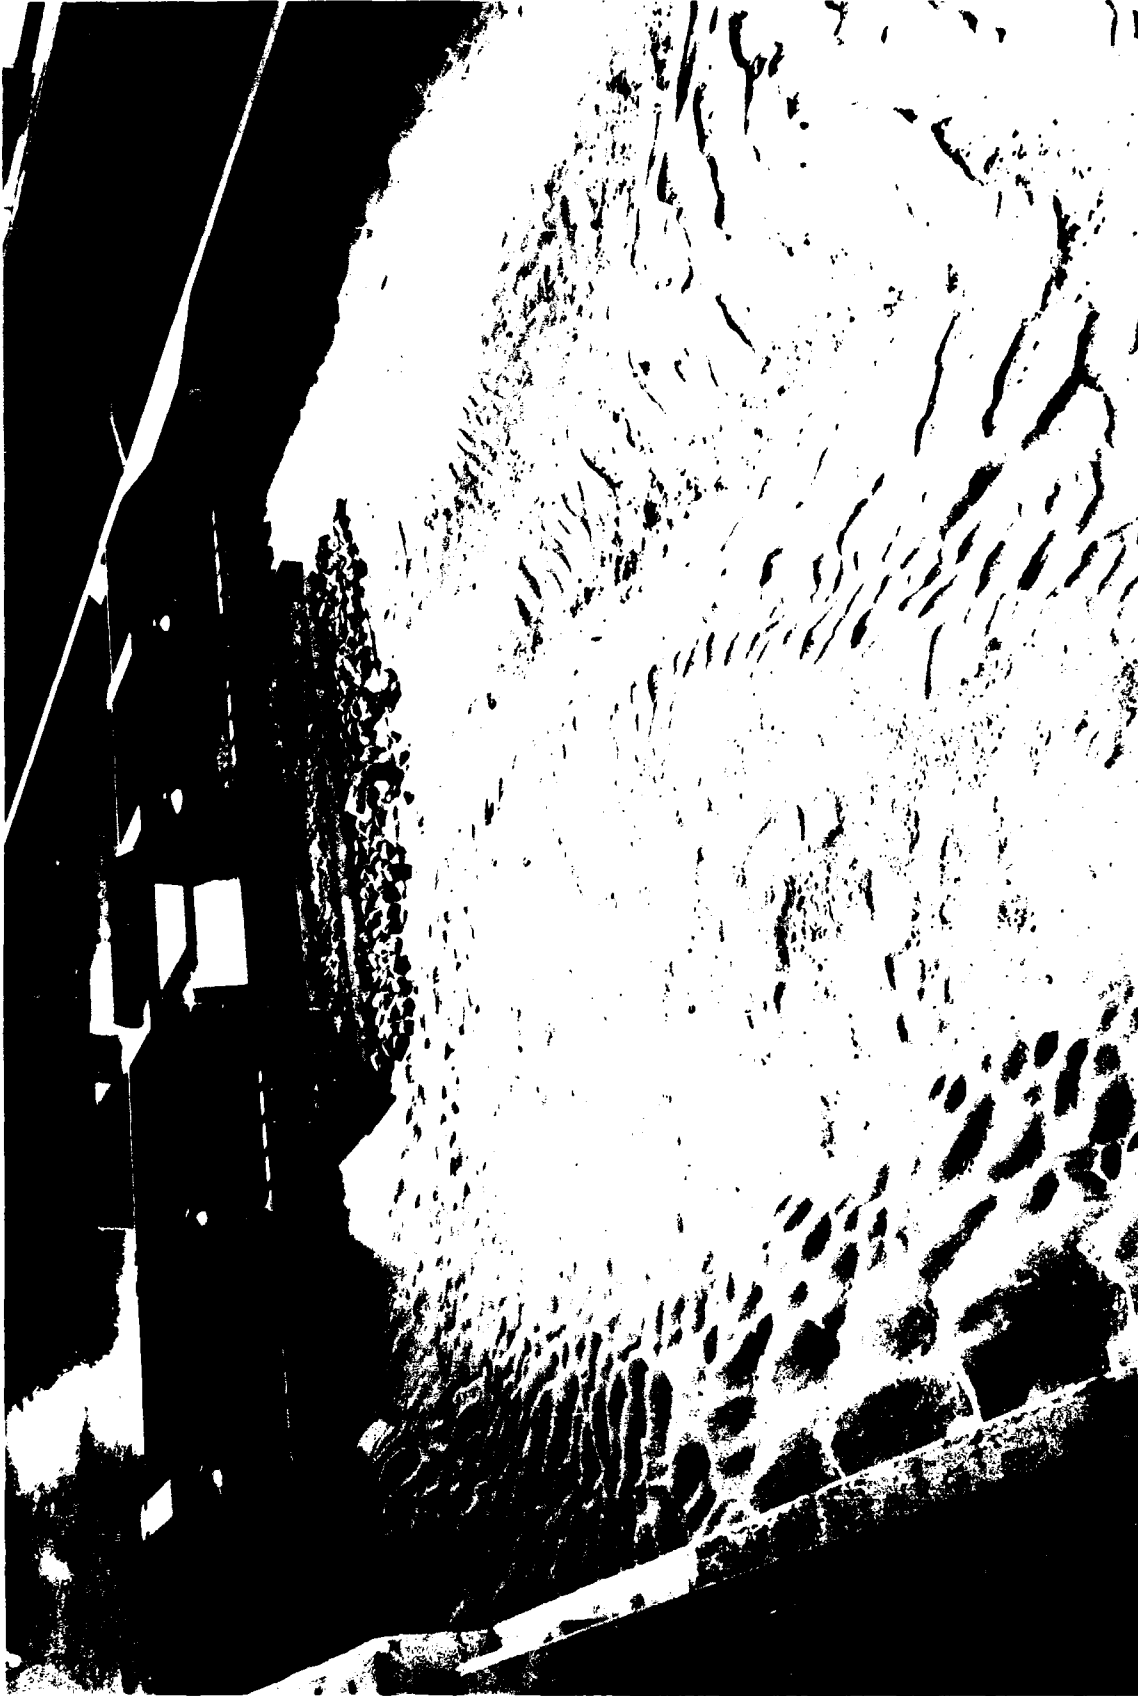
Photo 23. Scour downstream from type 19 scour protection plan after 5 hr of operation with normal upper pool, minimum tailwater, gate 3 open full

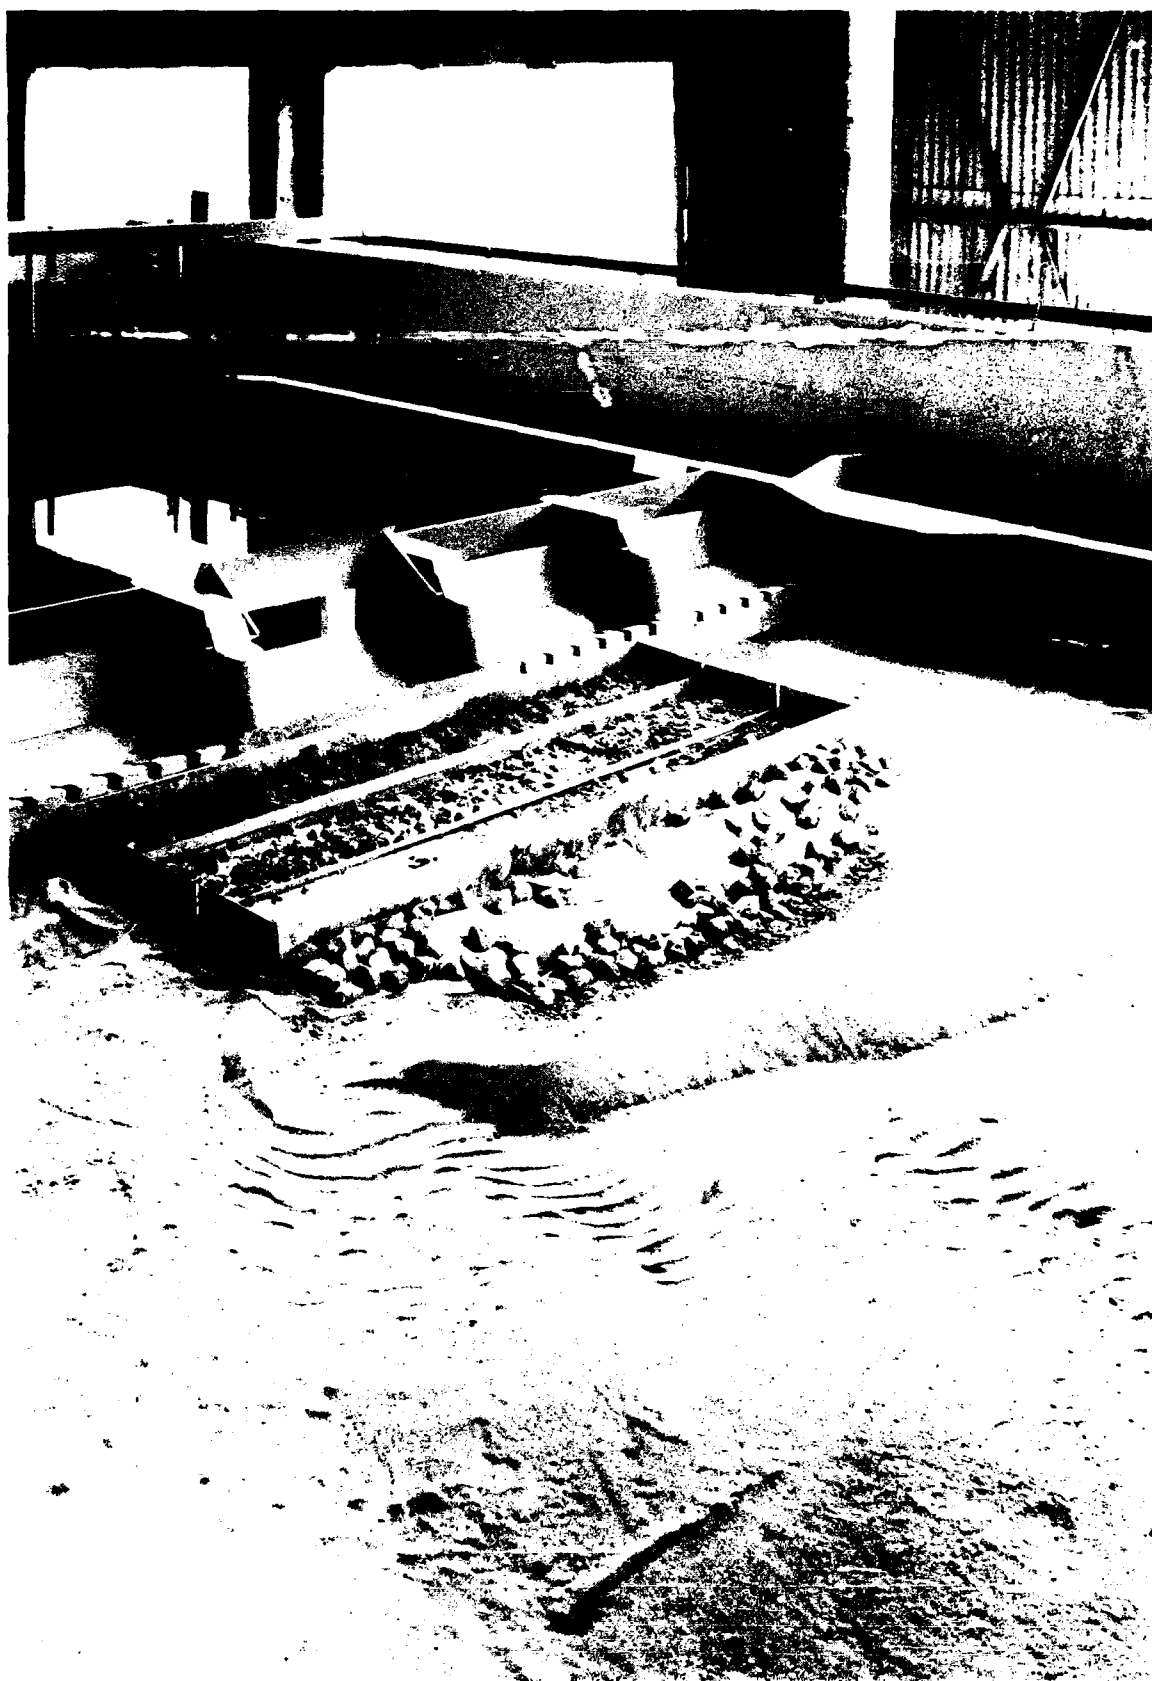
Photo 25. Scour downstream of type 20 scour protection plan after 5 hr of operation; normal upper pool, minimum tailwater, gate 3 open full
